Repair Instructions – Service No./Modi, Error list

2 List of Evita 2 dura/Evita 4 error numbers

Error list as at February 1998 (corresponding to SW 3.n of Evita 4/Evita 2 Dura)

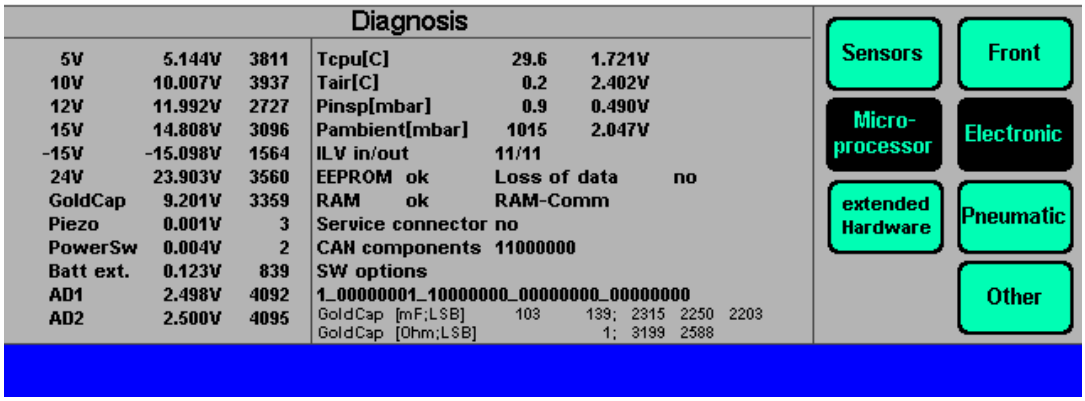
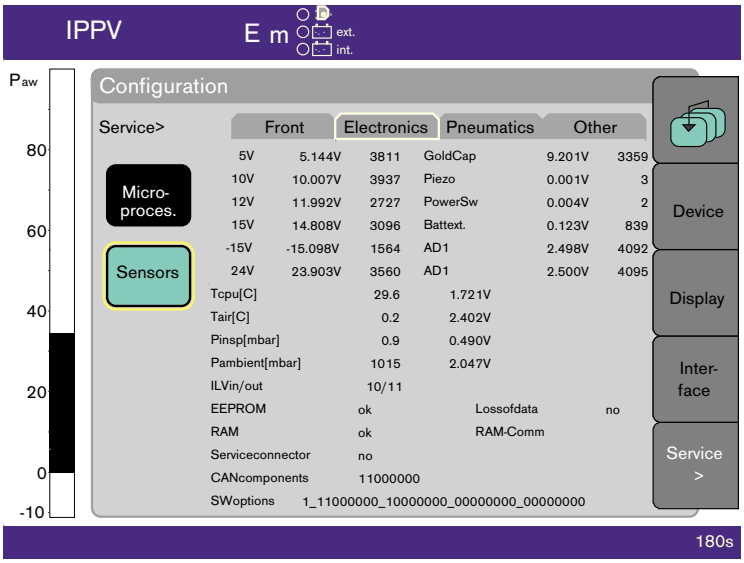
3.3.2 Diagnosis page “Microprocessor” of “Electronics”

5 V/12 V/15 V/ -15 V/24 V : Power pack supply voltages measured on CO2 Carrier PCB. Output of voltages and decimal values of AD conversion. There are no apparatus error messages with the following values:

5 V	=	4.5 V to 5.5 V
12 V	=	9.6 V to 14.4 V
15 V	=	14 V to 18 V
-15 V	=	-12 V to -18 V

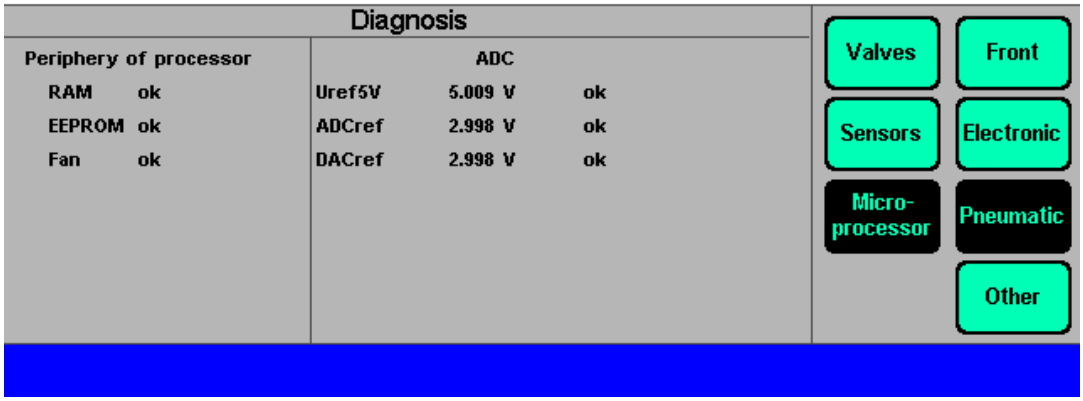
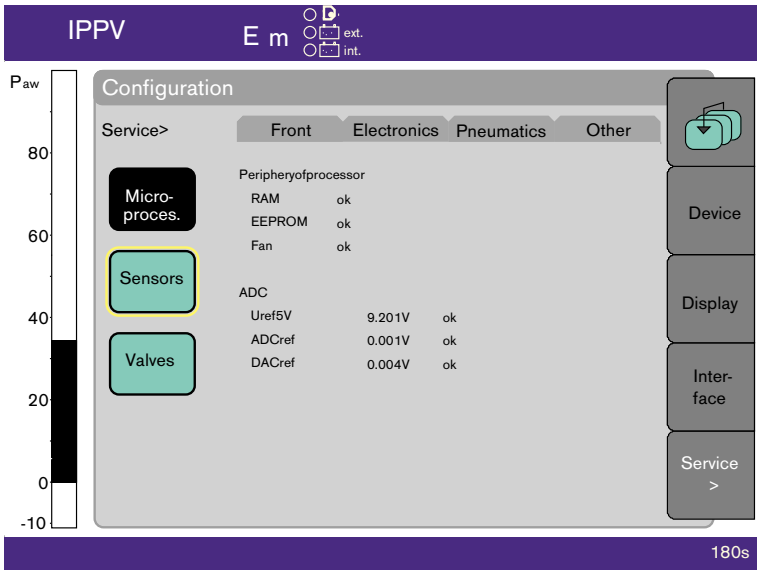
3.4.3 Diagnosis page “Microprocessor” of “Pneumatics”

Periphery of processor: Status of processor system of Pneumatic Controller PCB and fan for cooling electronics in pneumatics section. Error message is given in the event of deviation. Fan must be detected within 1 minute.

ADC: POutput of reference voltages of Pneumatic Controller PCB. The voltages are generated on this PCB and also read in. Error message is given in the event of deviation.
Set values:
Uref5V = 4.9V to 5.1V
ADCref = 2.9V to 3.1V
DACref = 2.9V to 3.1V
